## 6.0 SUMMARY OF SURVEYED ARCHITECTURAL RESULTS

## 6.0 SUMMARY OF SURVEYED ARCHITECTURAL RESOURCES

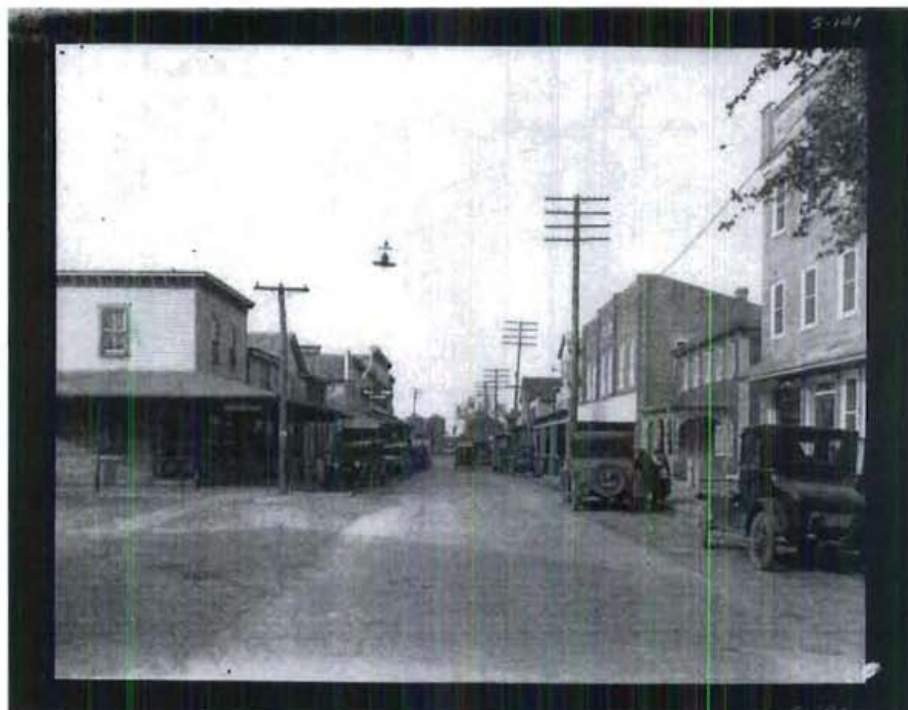
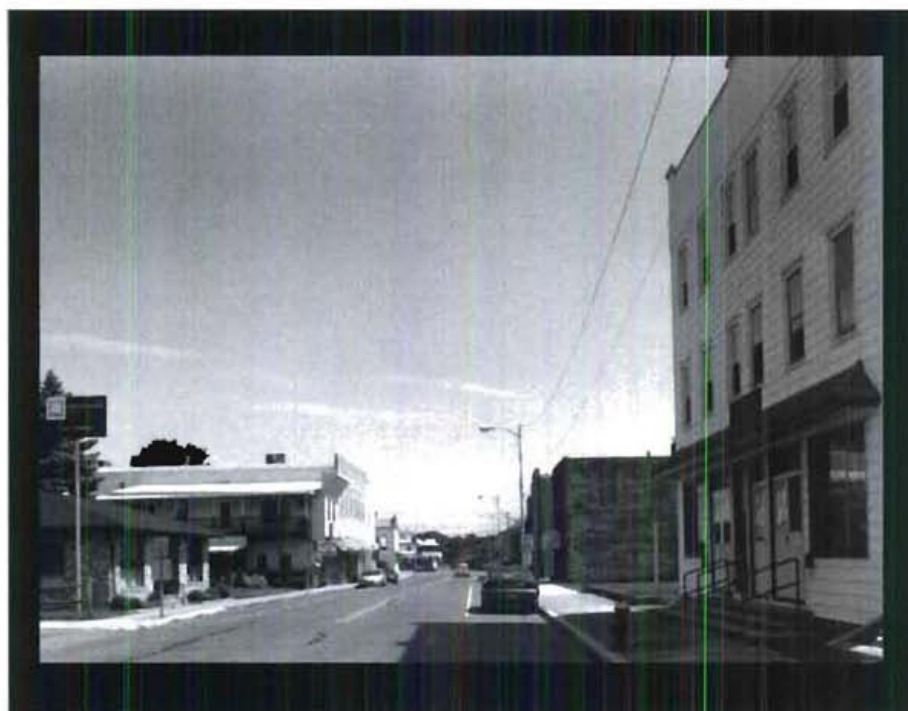
**Figure 5**  
**1926 and 2004 View of Commerce Street, Harrington, Looking North**  
 Harrington, Kent County, Delaware

Compared to the earlier part of the century, the downtown core within the potential Harrington Historic District has witnessed some building demolition in the later twentieth century. For example, Figure 5 shows a 1926 photograph of Commerce Street (then called Main Street), and below shows the same view in 2004. The overall historic scale and fabric of the building stock is still evident in the downtown today, but some buildings have been demolished (Figure 5). New buildings have been erected in their place, or in some cases, these lots remain empty. The southeast corner of Clark and Commerce streets for example, is devoid of buildings, with a modern Wilmington Trust edifice on the adjacent lot along Clark Street (Photograph 1). Other areas of the potential Harrington Historic District still display their mixed-use character and variety of scales, building heights, and materials, exhibiting some historic details including cornice work, original window and door trim, etc. (Photographs 2 through 4).

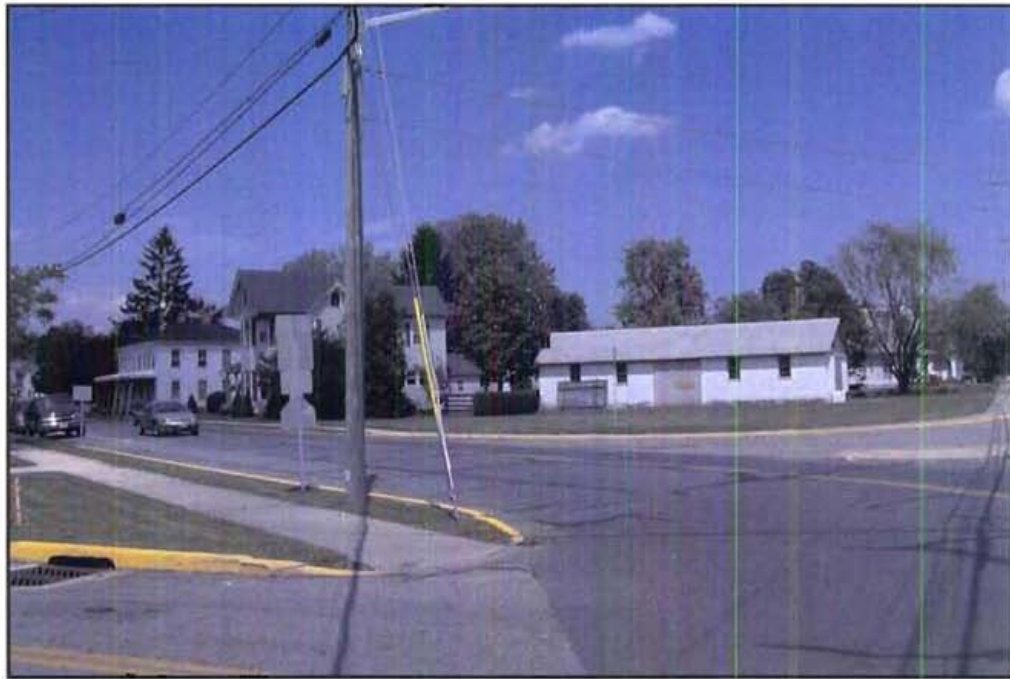
**Photograph 5:** The “5 Points” Intersection, Taylor Hardware Store, shed in background, view to north (August 2004).

The “Five Points” (Photographs 5 and 6) area of the project has also witnessed several demolitions of buildings, including K-2242-2241 (Potter’s Store; Photograph 6) and K-2571 (“Fleming Estate”), both located on the north side of the intersection. The former “Potter’s Store” lot is now used as a community park, known as Heritage Park (Photograph 6). The park has a flagpole, two benches with white stone gravel under them, and a paved walkway. Landscaping includes grass and low shrubbery, as well as in-ground, flat dedication stones/markers. The small park was built in 1991. The “Five Points” intersection is just outside of the potential Harrington Historic District.

General Description: This is an early-twentieth century, concrete-block, vernacular storage shed that is used for the hardware store (Photograph 5, center of photograph).

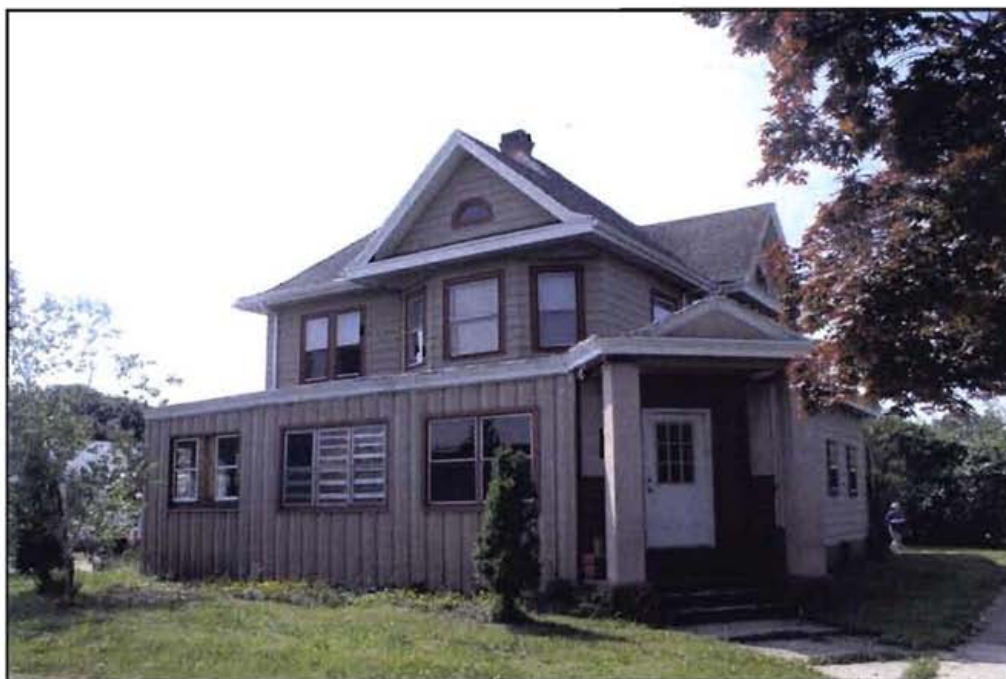
**Photograph 7:** K-2527. View to southeast (August 2004).

General Description: This property includes a two-and-one-half story, Queen Anne style residence (Photograph 7). Alterations to the building include porch enclosure(s) and re-siding of the exterior. The house has been extensively remodeled, and it also includes a modern garage.

National Register Evaluation: Not eligible.

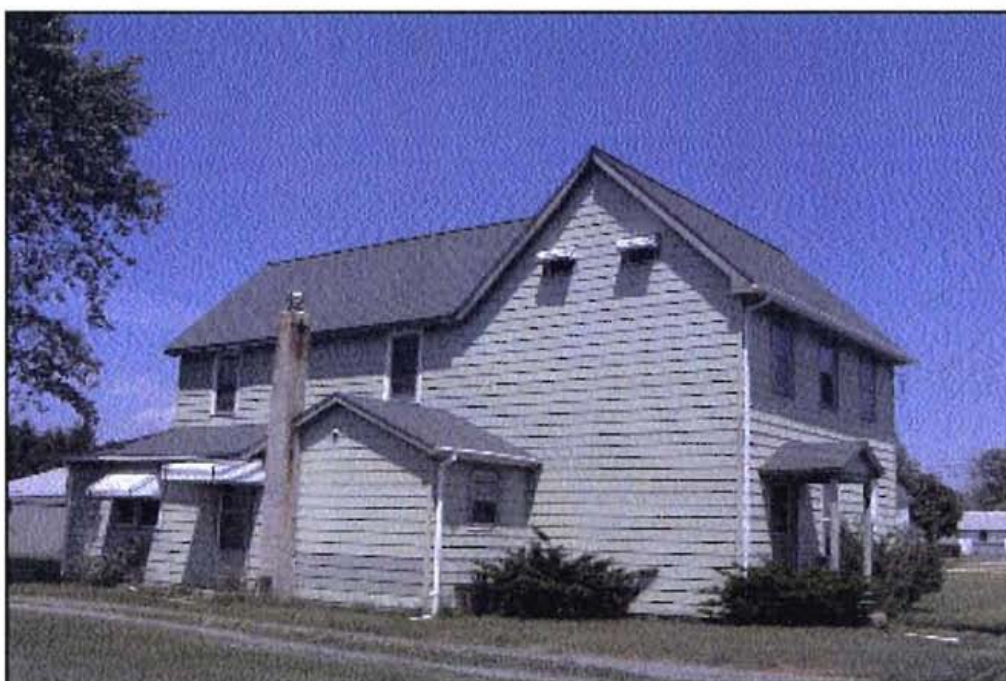
**Photograph 8:** K-2572. View to southeast (August 2004).

General Description: This property includes a late-nineteenth-century, vernacular frame residence (Photograph 8). Some of the windows and door(s) have been replaced, and there is a later addition on one side of the building.

National Register Evaluation: Not eligible.

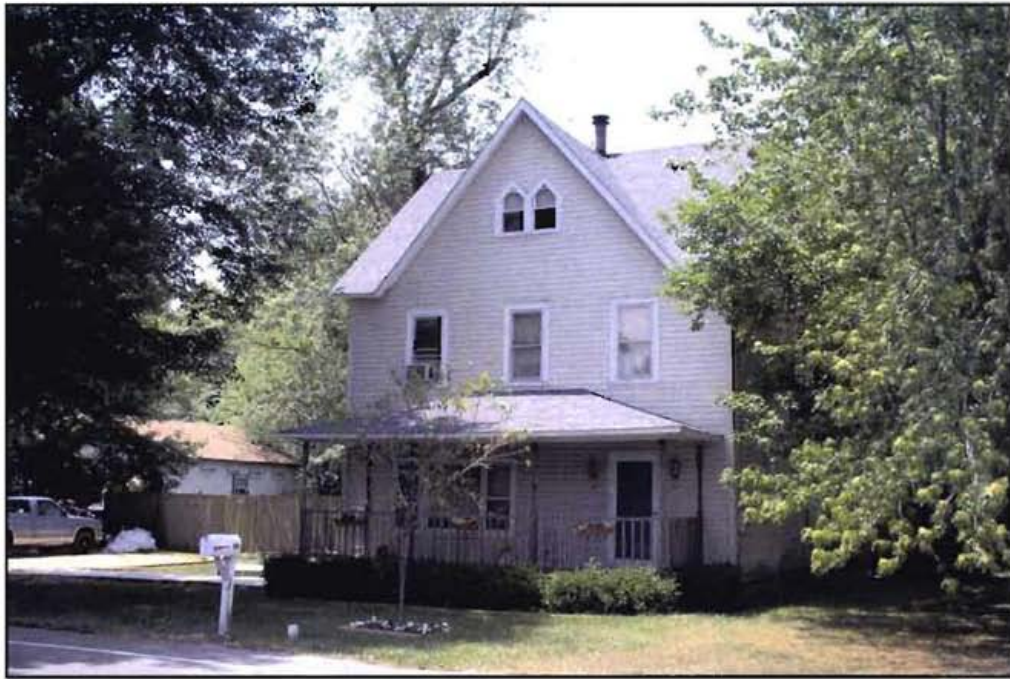
**Photograph 9:** K-2663. View to west (June 2004).

General Description: This residence is turn-of-the-century Victorian dwelling (Photograph 9). Built ca. 1900, it is a two-story dwelling with a front-facing gable and a (replaced) picture window on the facade. The house has a full-width, hipped-roof porch.

National Register Evaluation: Not eligible.

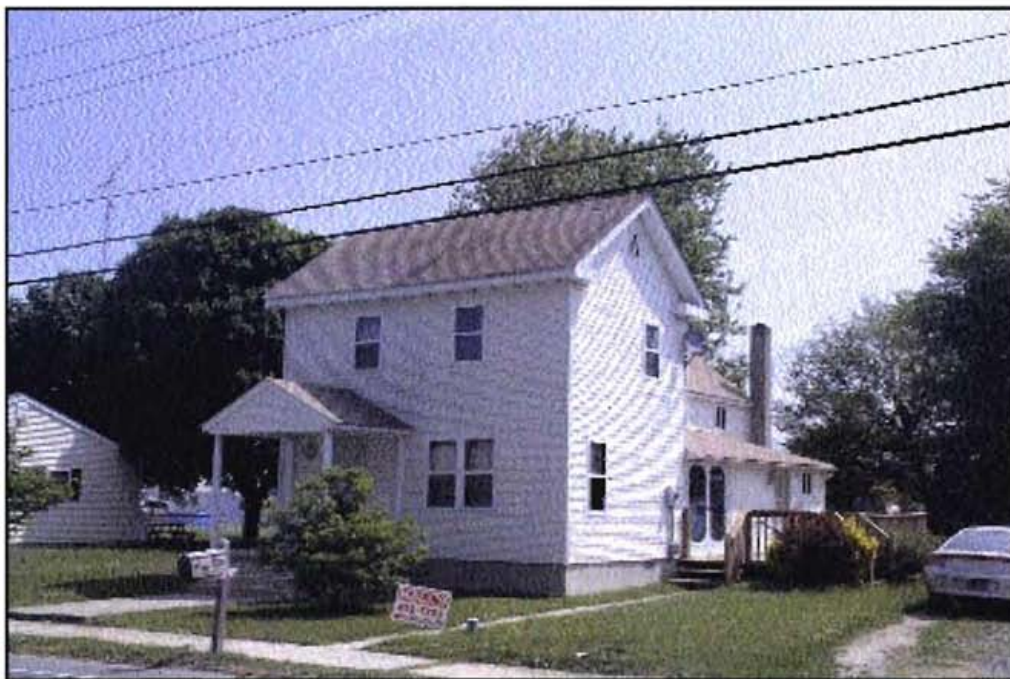
**Photograph 10:** K-2664. View to northeast (August 2004).

General Description: This property includes a nineteenth-century, side-gable, vernacular, frame residence (Photograph 10). The walls of the dwelling are clad in vinyl siding that imitates German lap. There is also a later storage shed and garage on the property.

National Register Evaluation: Not eligible.

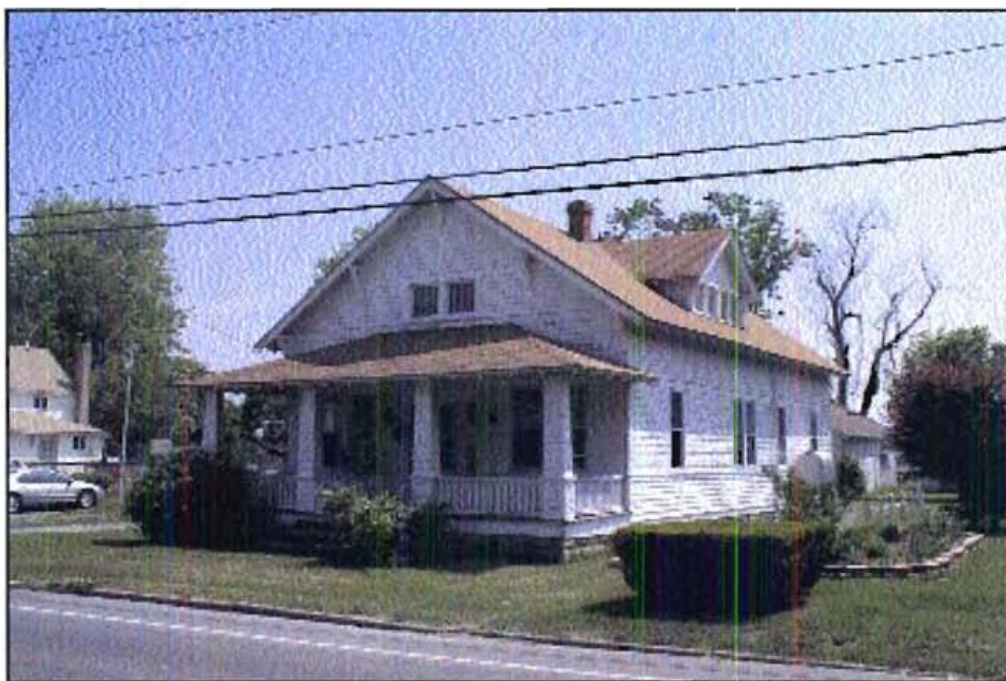
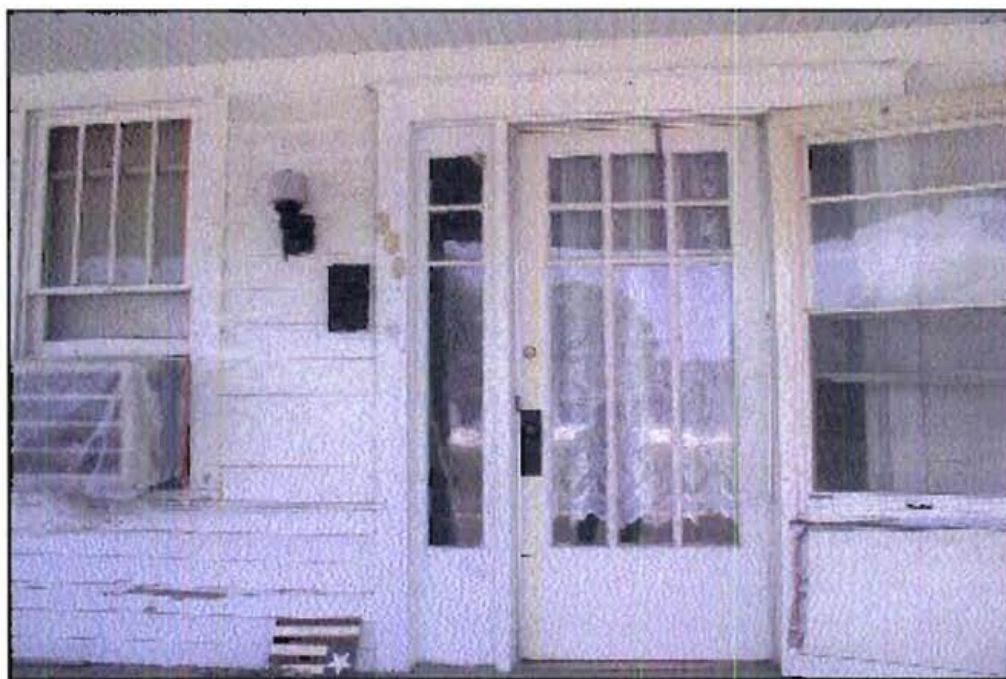
**Photograph 11:** K-2665. View to northeast (August 2004).

General Description: This residence is a vernacular interpretation of the Craftsman-Bungalow style of architecture (Photographs 11 and 12). Built ca. 1925, it is a one-and-one-half story dwelling with a front-facing gable. The house has a full-width, hipped-roof porch, which is supported by battered posts. A transom and sidelights surround the front door.

National Register Evaluation: Eligible; Criterion C.

**Photograph 12:** K-2665. Detail of front door, view to east (August 2004).

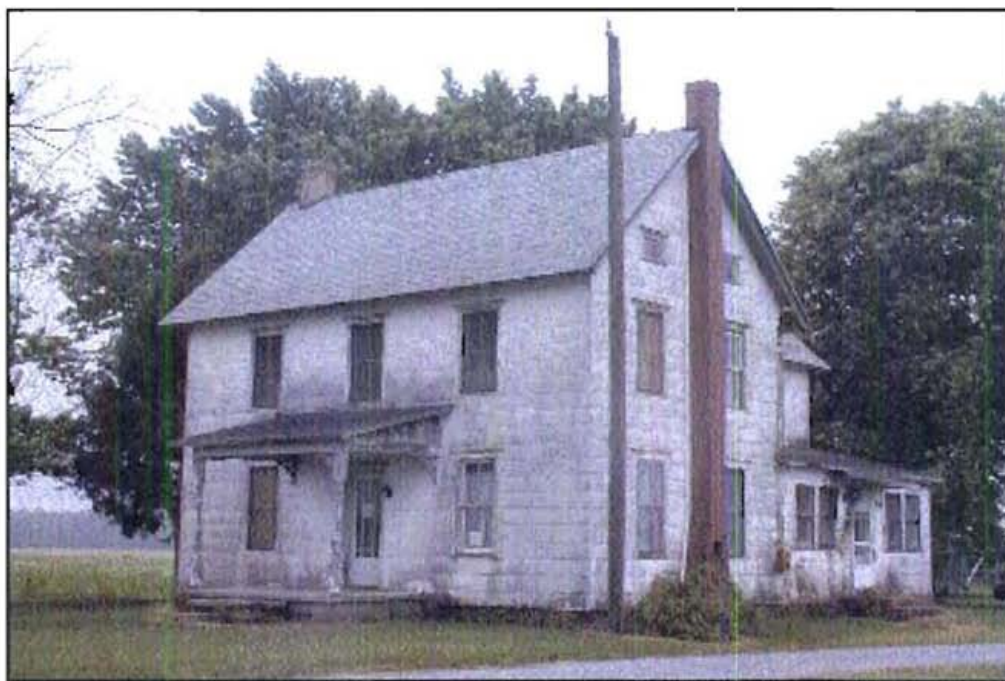
**Photograph 13a:** K-4615. View to southwest (August 2004).

General Description: This residence is a late-nineteenth-century, vernacular, wooden frame residence with a cross-gable (Photograph 13a). It is covered with asbestos siding. There is also a group of outbuildings dating from the early to the late twentieth century (Photographs 13b-13g).

National Register Evaluation: Not eligible.

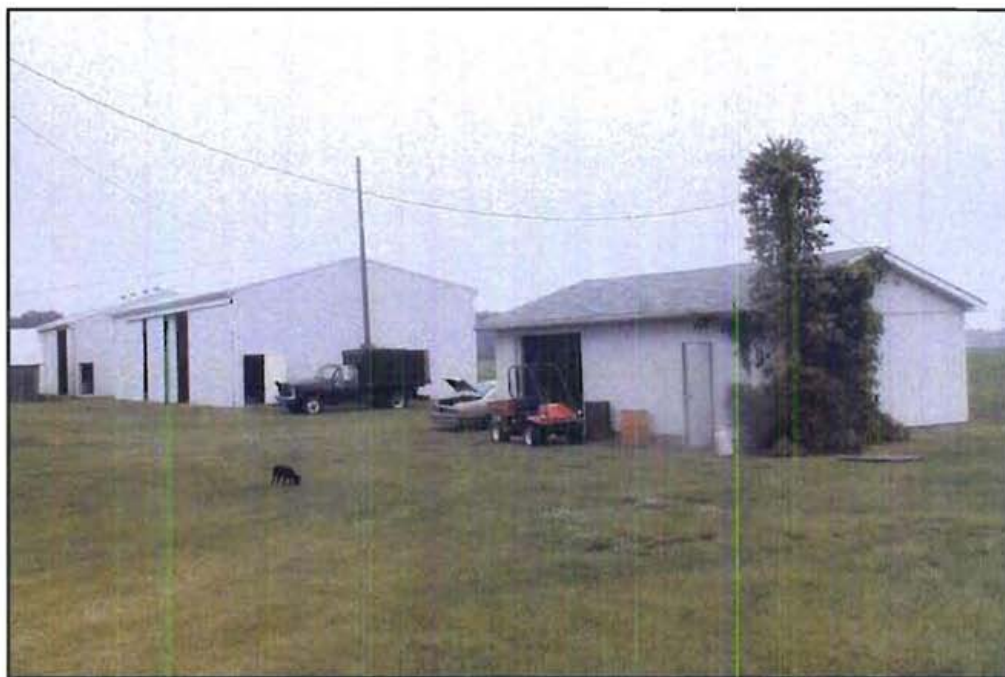
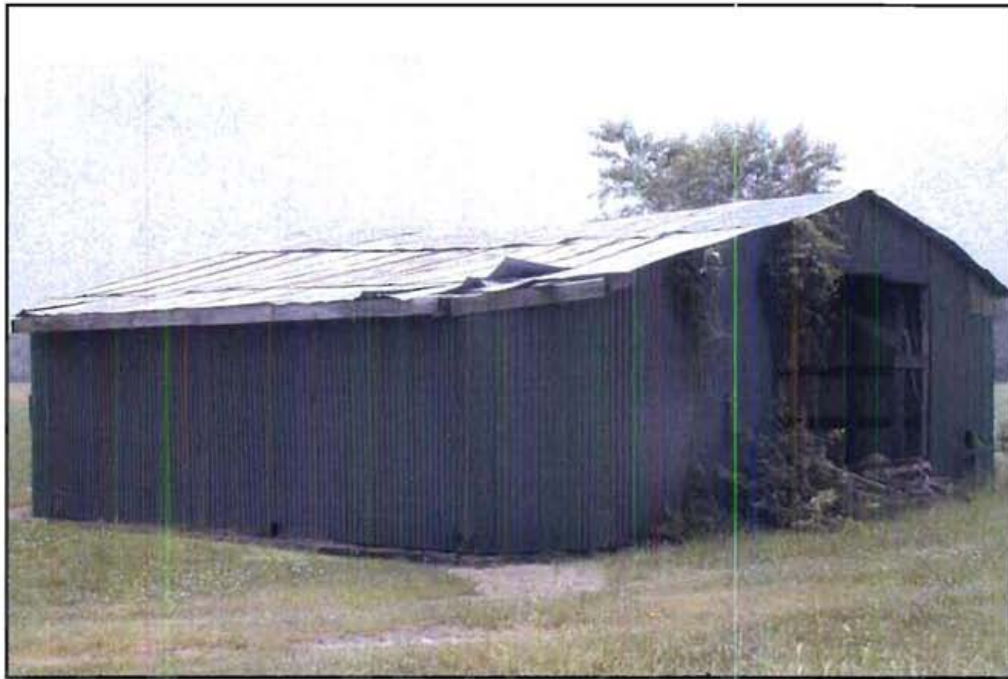
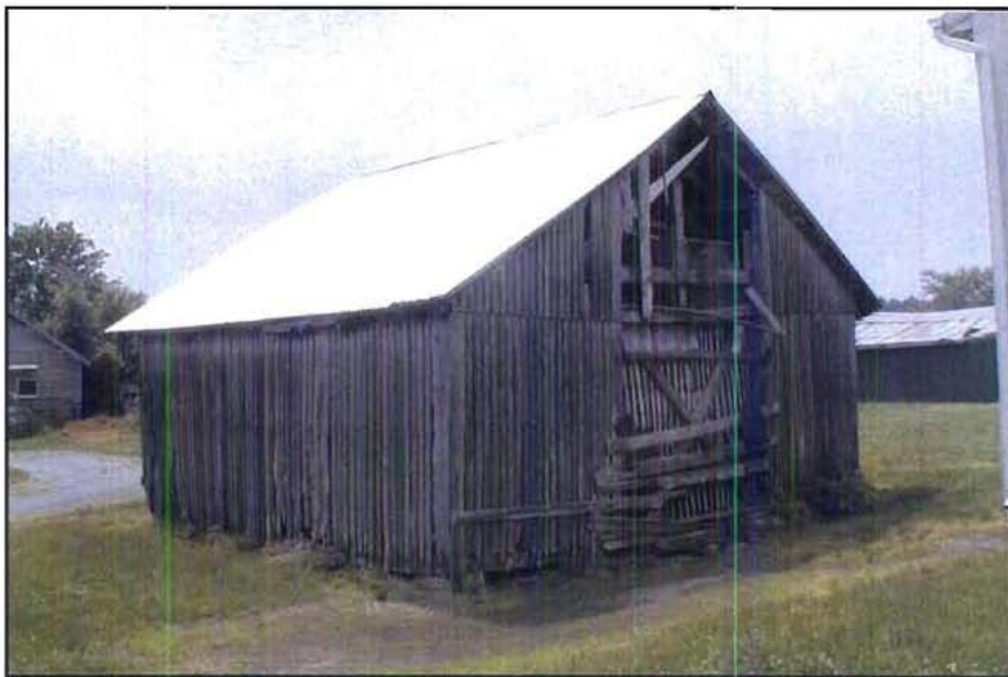
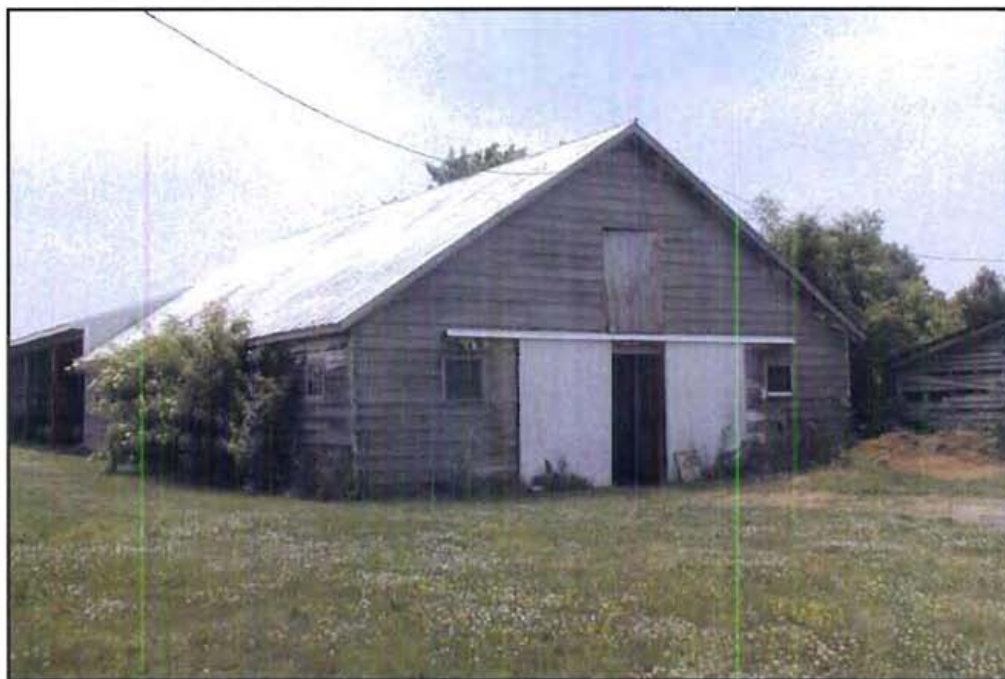
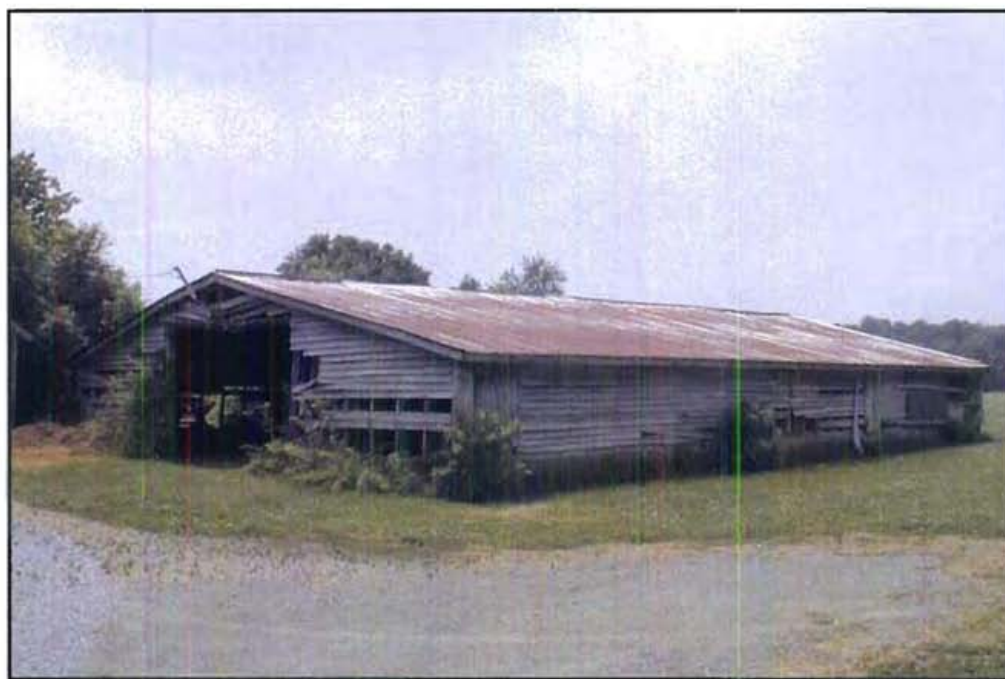
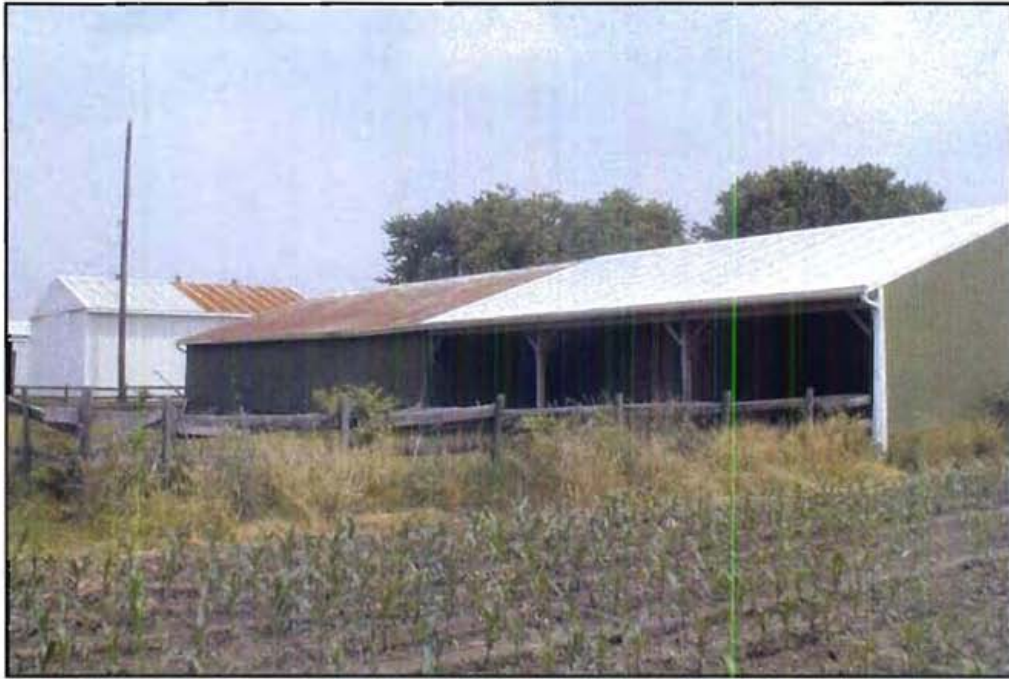
**Photograph 13b:** K-4615. Modern sheds, Nos. 1, 2, and 3 (from left of photograph to right). View to northwest (July 2004).

**Photograph 13c:** K-4615. Utility shed. View to southwest (July 2004).

**Photograph 13d:** K-4615. Corncrib, view to southwest (July 2004).

**Photograph 13e:** K-4615. Stable. View to southwest (July 2004).

**Photograph 13f:** K-4615. Wagon shed. View to southwest (July 2004).

**Photograph 13g:** K-4615. Loafing shed, view to northeast (July 2004).

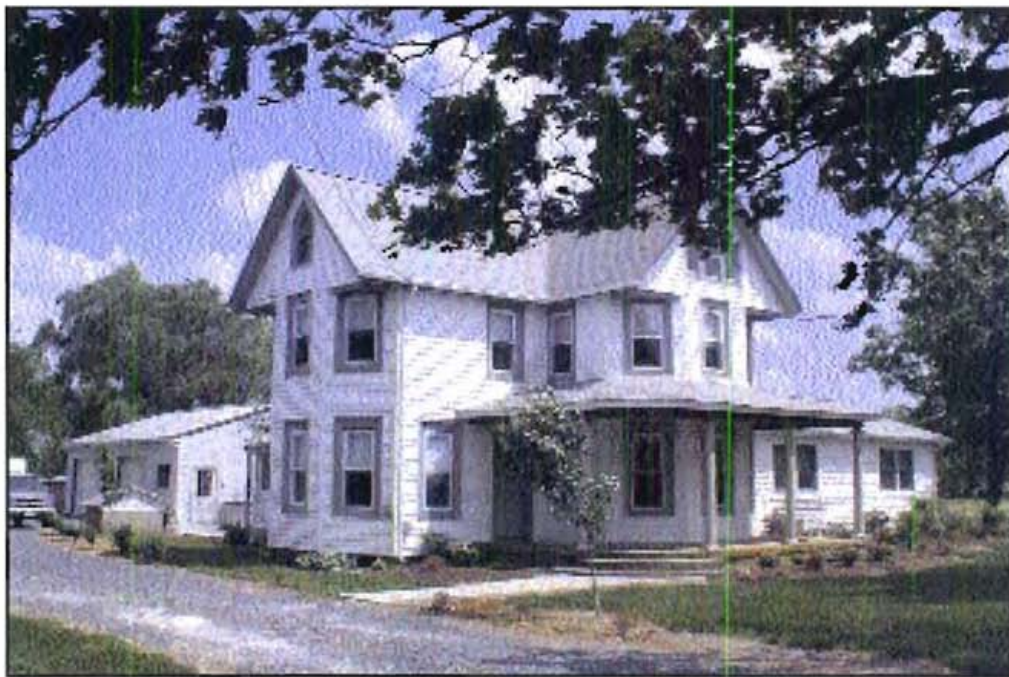
**Photograph 14:** K-4616. View to southeast (August 2004).

General Description: This residence is a turn-of-the-century, wooden frame building with cross-gables (Photograph 14). It features some Queen Anne detailing, but the vinyl siding and the large new addition off to one side obscure some of this. There is also a group of unremarkable outbuildings on this property that range from the early to the late twentieth century.

National Register Evaluation: Not eligible.

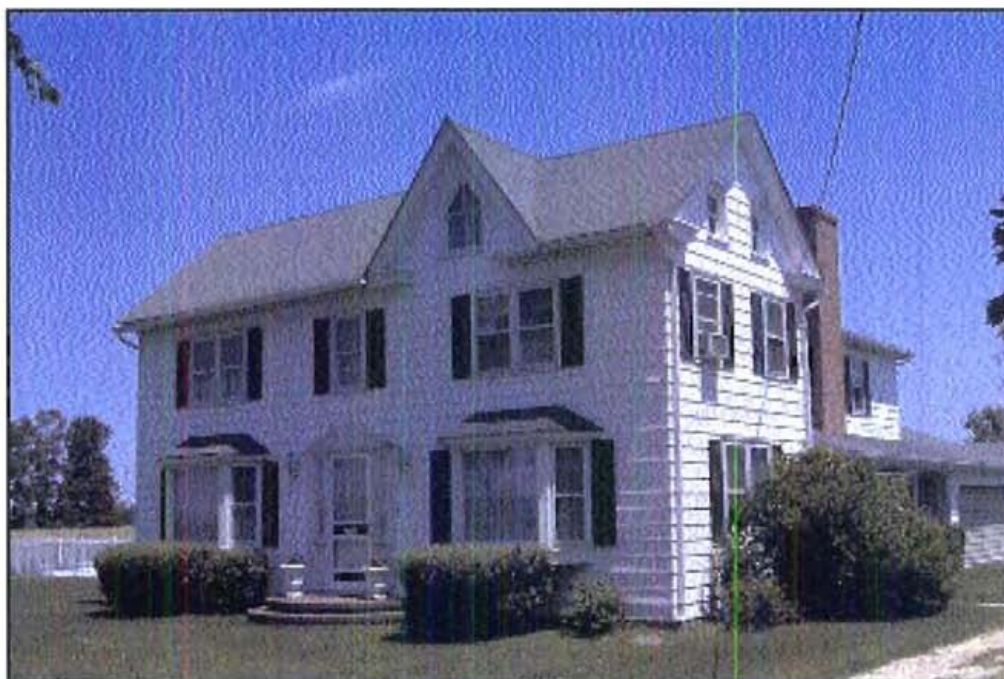
**Photograph 15:** K-4617. View to northeast (August 2004).

General Description: This residence dates from the late nineteenth century. It is wooden frame and covered with vinyl siding (Photograph 15). The house has been extensively remodeled and it is now connected to a large garage and a fenced concrete patio with an in-ground swimming pool.

National Register Evaluation: Not eligible.

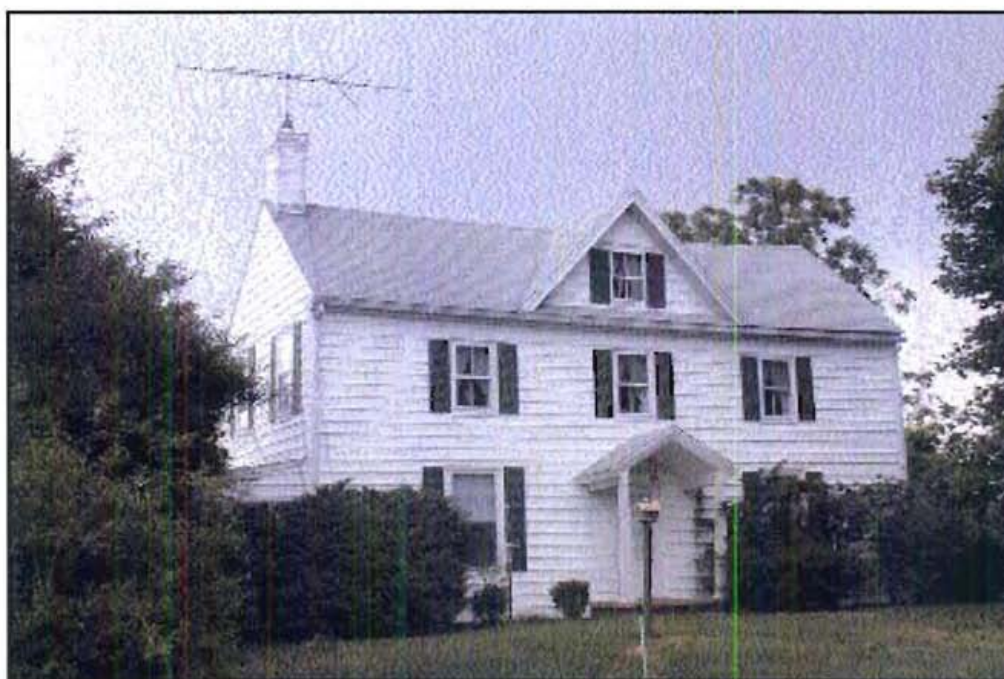
**Photograph 16a:** K-4622. View to west (July 2004).

General Description: The earliest section of the residence at this farmstead dates to ca. 1865, and there is a *circa*-1900 addition (Photograph 16a). There have been extensive renovations and expansions, and many original details have been obscured. There are a number of outbuildings here as well, which span a broad date range (Photographs 16b-16h). Most are typical examples of balloon-frame construction, twentieth-century pole construction, and mid-twentieth-century concrete-block construction.

National Register Evaluation: Not eligible.

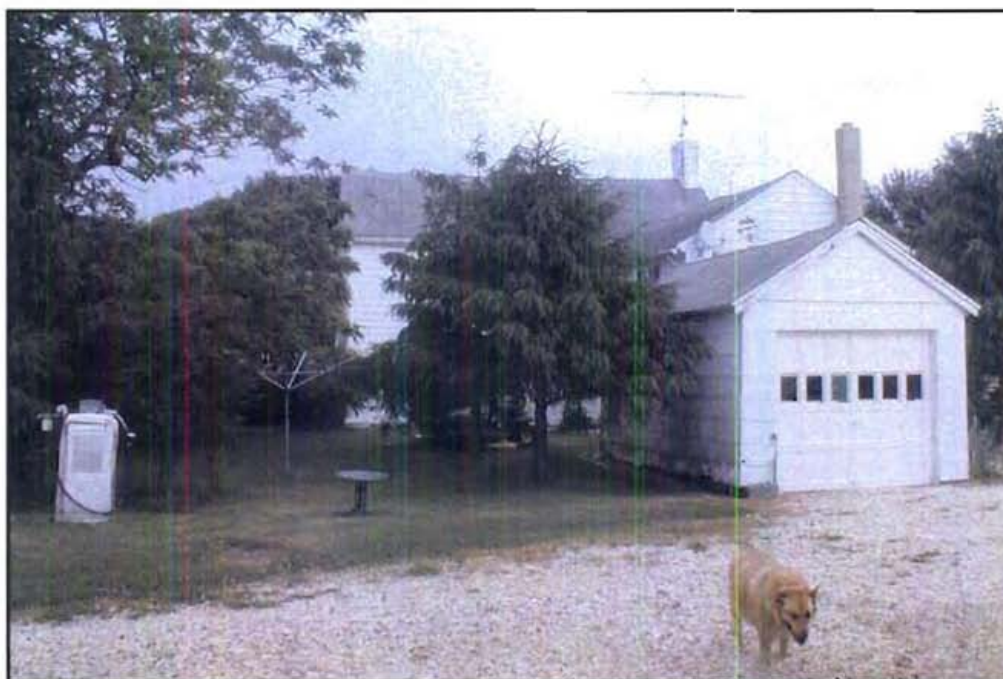
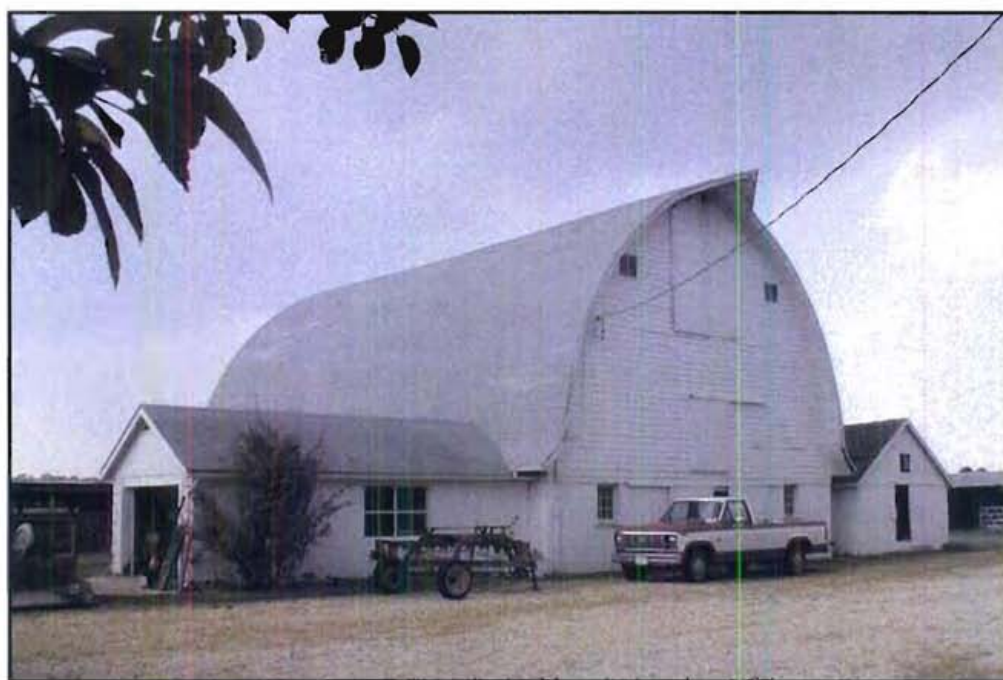
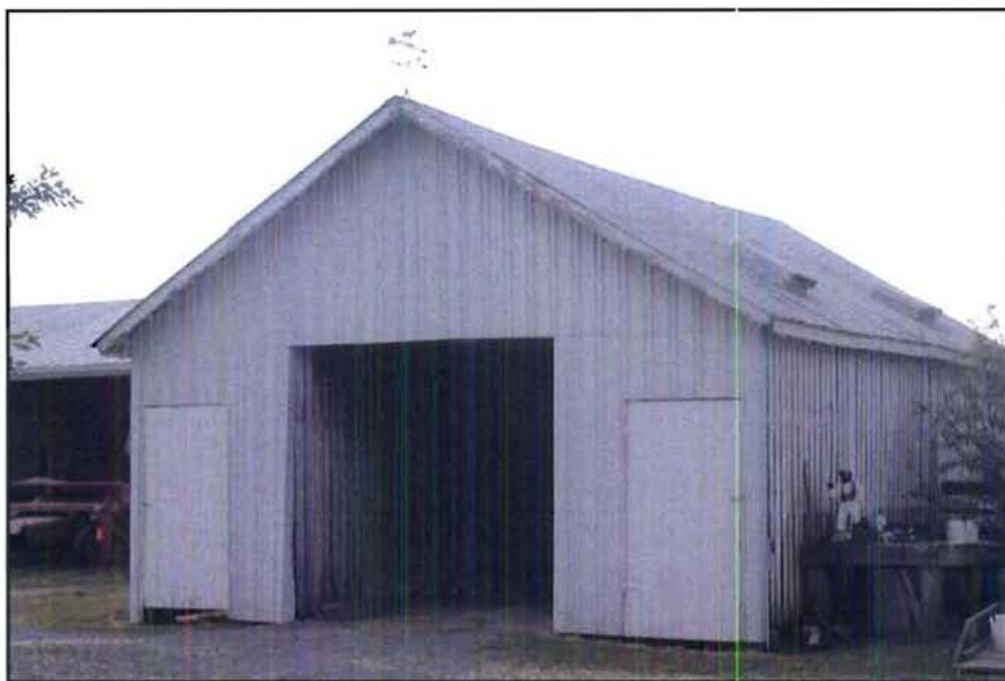
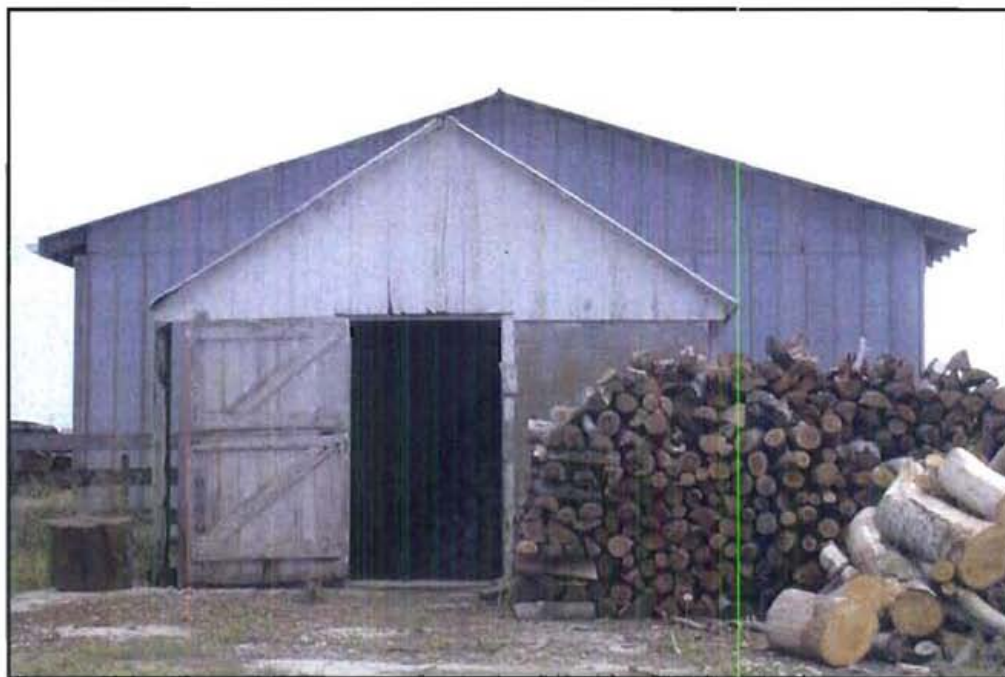
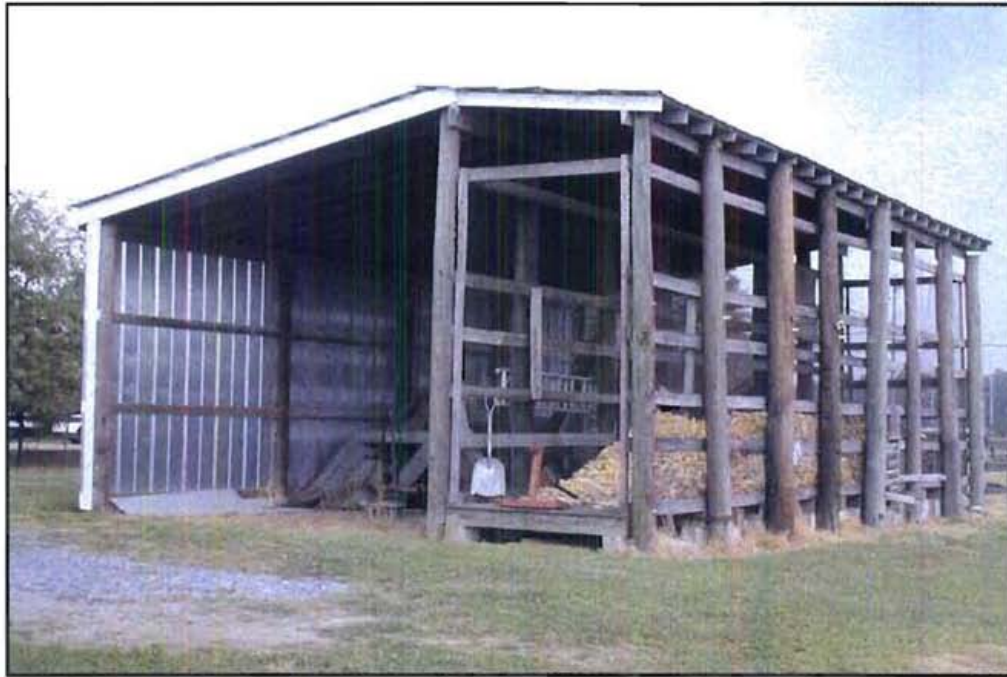
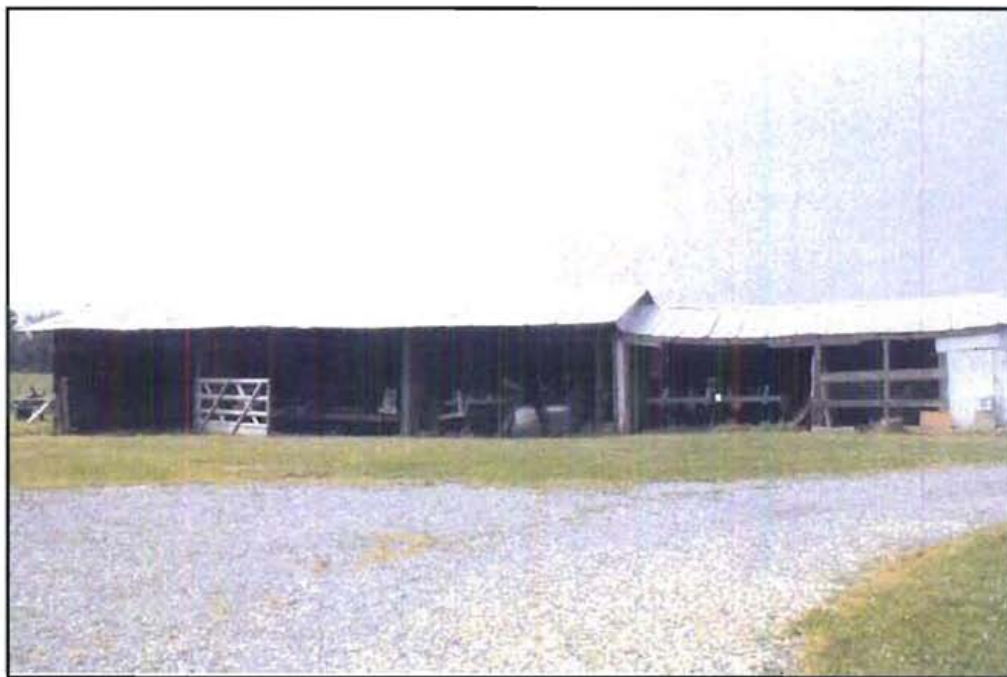
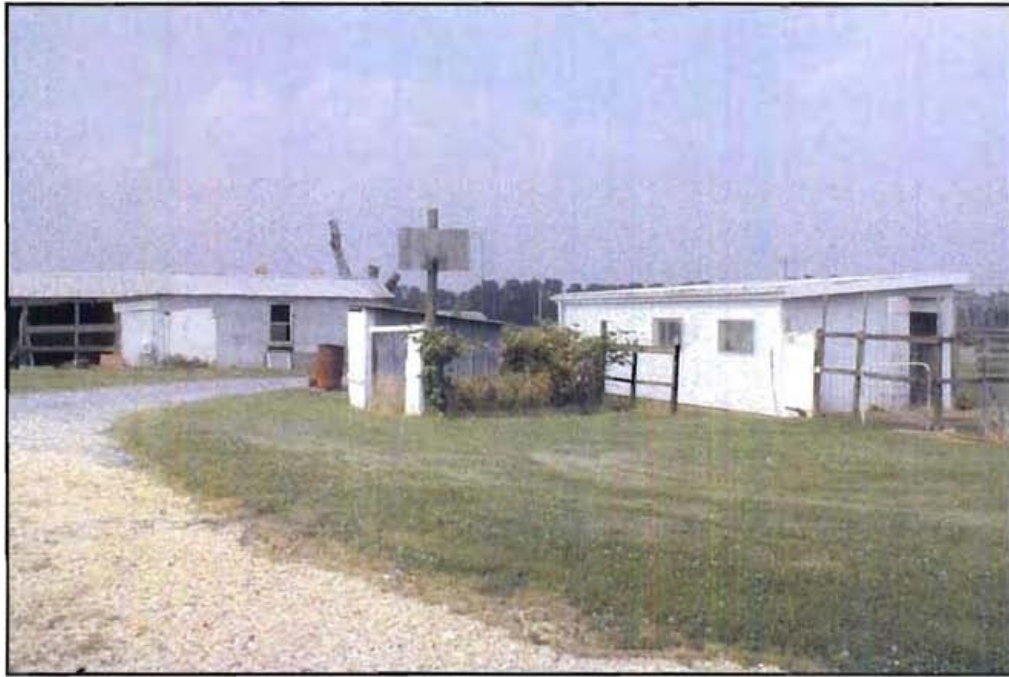
**Photograph 16b:** K-4622. Garage attached to rear of house (former converted smokehouse). View to southeast (July 2004).

**Photograph 16c:** K-4622. Dairy barn with milk house and granary; view to northwest (July 2004).

**Photograph 16d:** K-4622. Corncrib with wagonway in center. View to west (July 2004).

**Photograph 16e:** K-4622. Firewood storage shed, view to south (July 2004).

**Photograph 16f:** K-4622. Combine shed/corncrib. View to southeast (July 2004).

**Photograph 16g:** K-4622. Wagon shed with attached poultry shed, view to north (July 2004).

**Photograph 16h:** K-4622. Poultry sheds, view to north (July 2004).

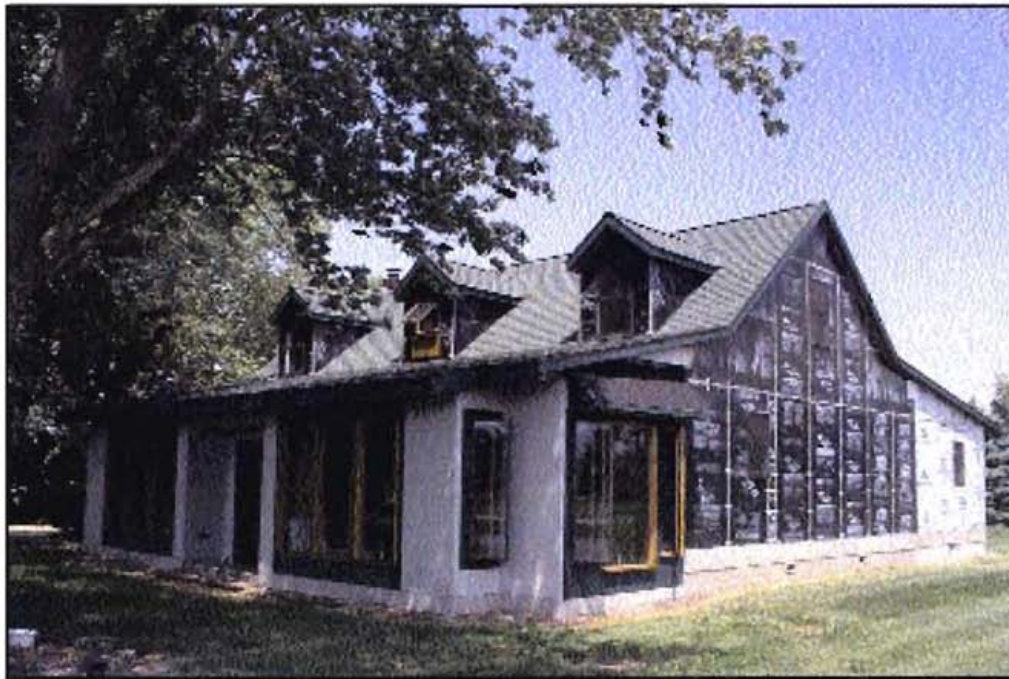
**Photograph 17:** K-7381. View to northeast (August 2004).

General Description: This residence has a massed plan consisting of a bungalow form with neoclassical elements and extensive modern alterations (Photograph 17).

National Register Evaluation: Not eligible.

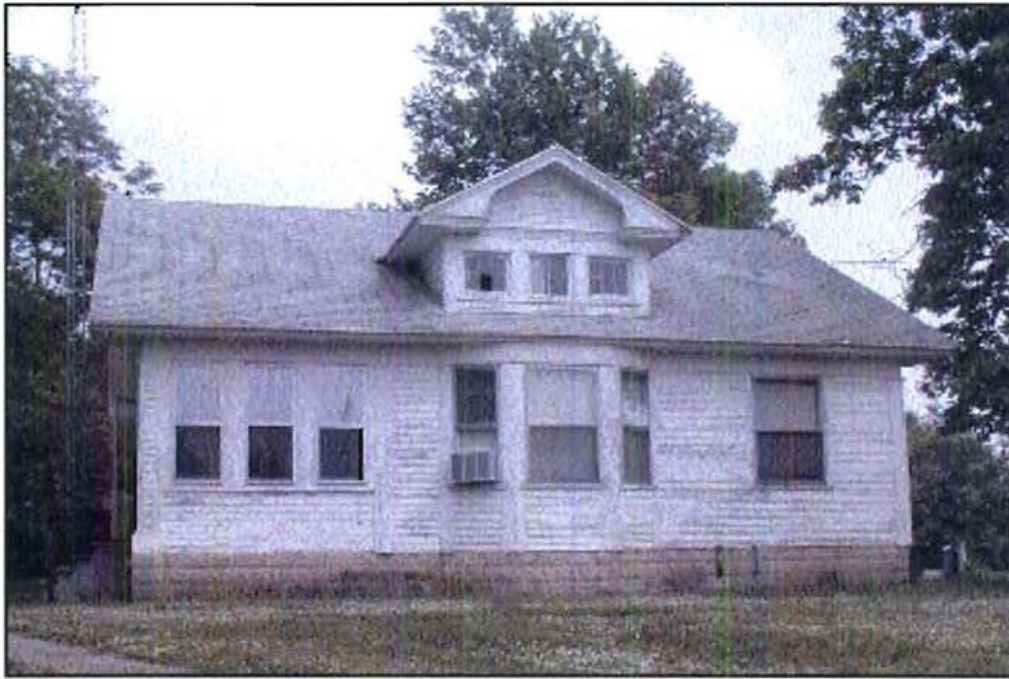
**Photograph 18:** K-7382. View to east (August 2004).

General Description: This residence dates from the first quarter of the twentieth century, and it is a Bungalow period interpretation of the Colonial Revival style, with a single story (Photograph 18). There are also several contemporaneous outbuildings here, including a small barn. The surrounding area may have been farmed at one time.

National Register Evaluation: Eligible under Criteria A and C.

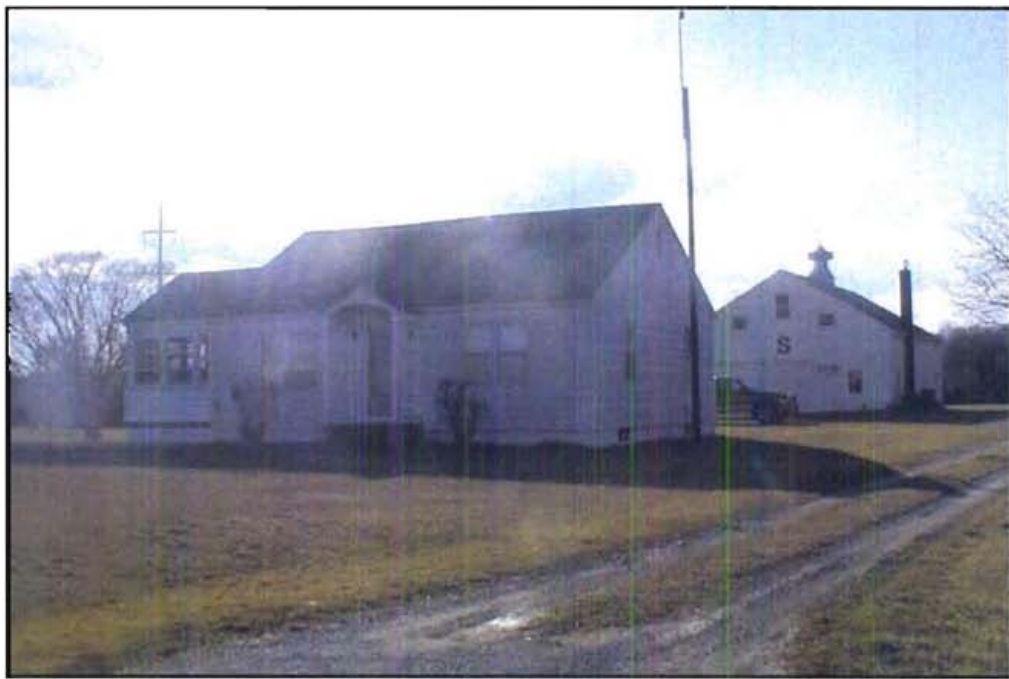
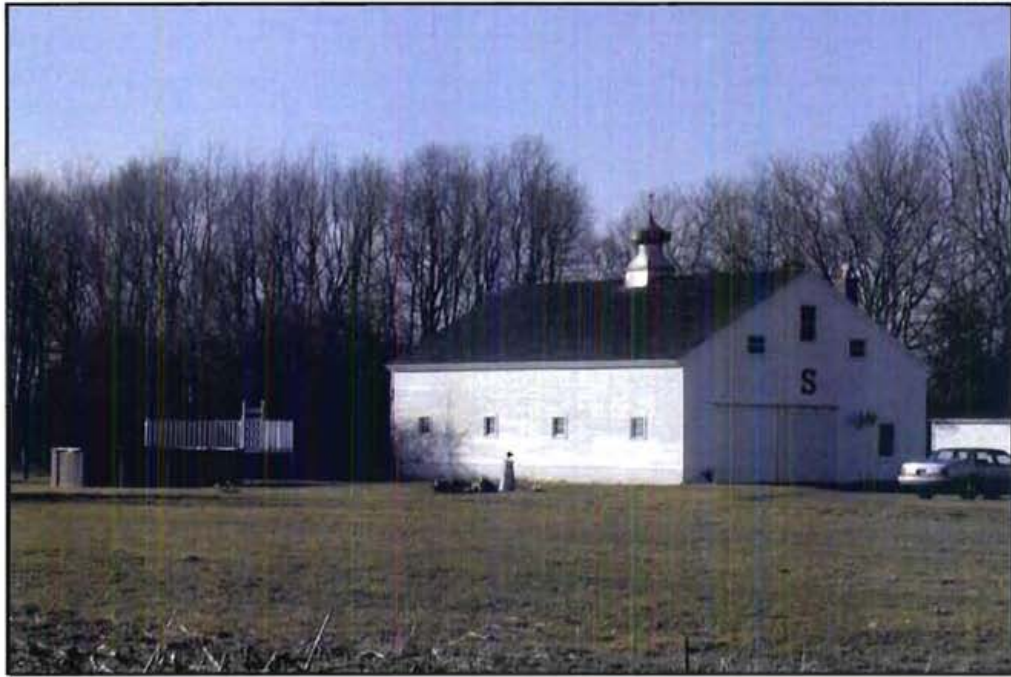
General Description: This small, single-story residence dates from 1949 (Photographs 19 and 20). There are also outbuildings here, including a large barn and a shed.

National Register Evaluation: Not eligible.

**Photograph 19:** K-7383. House, barn, and shed. View to northwest (February 2005).

**Photograph 20:** K-7383. Barn. View to northwest (February 2005).
